ELLEBOGEN SALT SPRAY CHAMBER RESULTS ZINC NICKEL + 2 LAYER PU PAINT

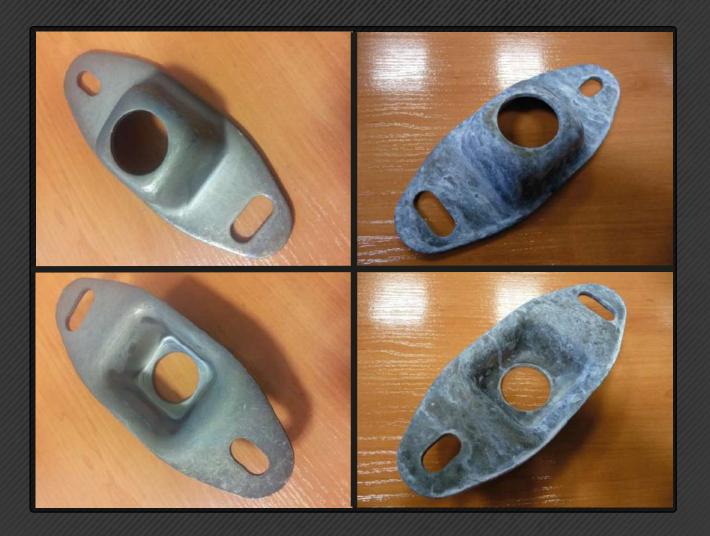
- The results obtained after the test would be the following:
 - For the base, the part did not show any traces of red rust after 768 hours.

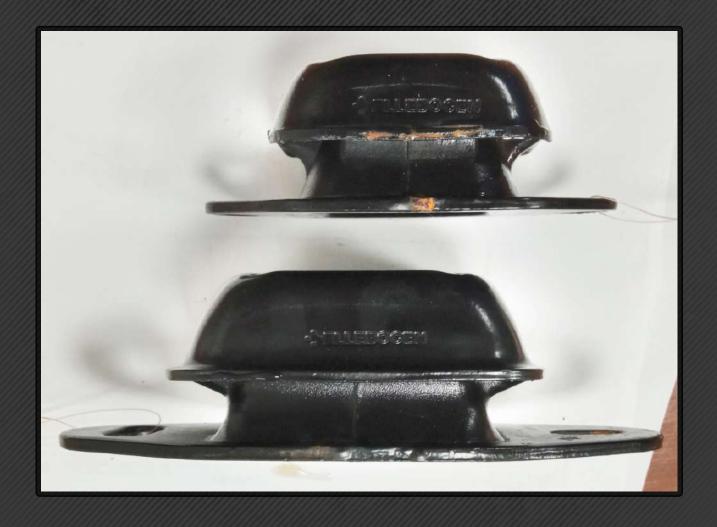
- The results obtained after the test would be the following:
 - For the complete parts, both parts showed the first traces of red rust after 528 hours. Before that point, no signs of white rust was detected.
