**ELLEBOGEN 75 & 100**

# FATIGUE TEST REPORT

- The aim of this document is to summarize the results of the fatigue test that has been carried out with a Ellebogen 75 (Ref. 128270-08341) and Ellebogen 100 (Ref. 128377-08351) marine engine mounts.

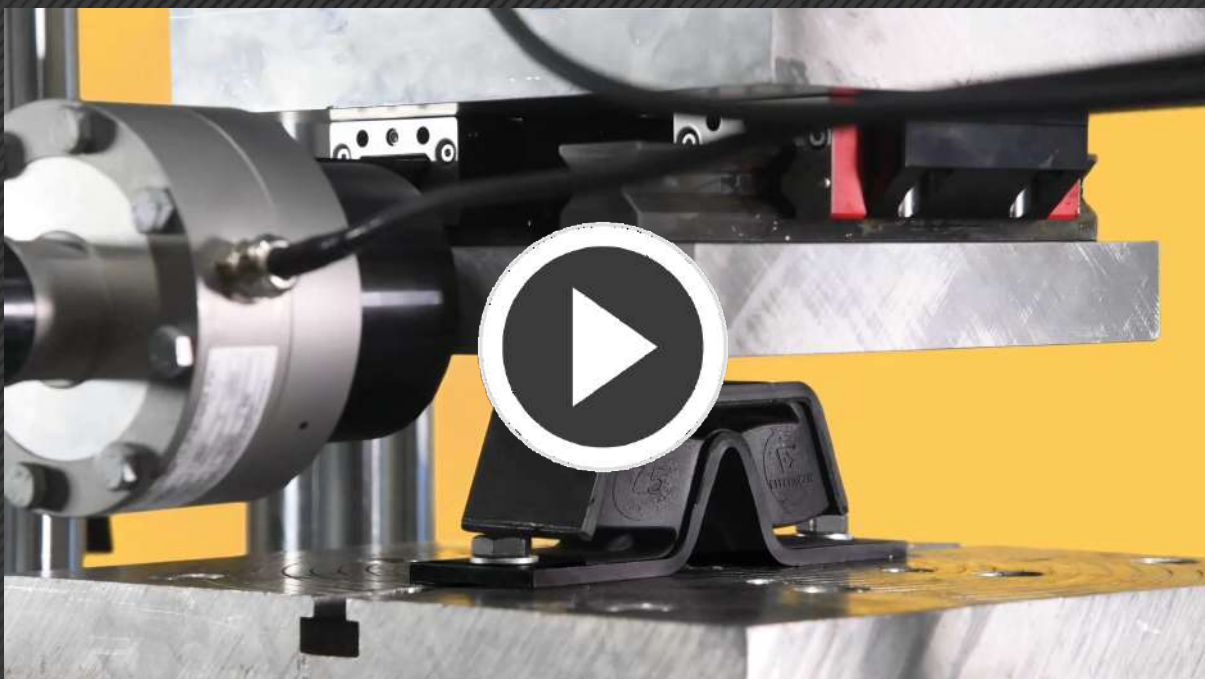
## Video of the test:

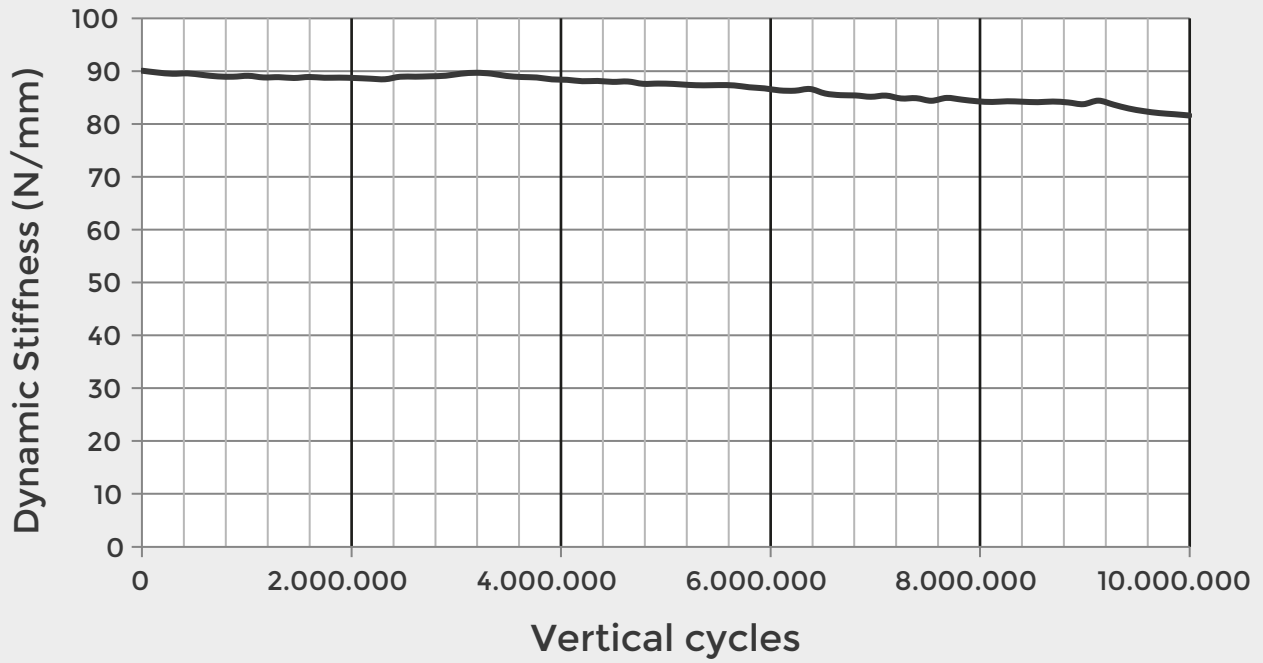
## Ellebogen 75 dynamic stiffness evolution:

- The structural integrity of the mounts is intact.
- The dynamic stiffness remains similar during the whole fatigue test for both mounts, decreasing less than 10% during the test.
- The loss angle (damping) remains similar during the whole fatigue test.
- Both mounts show some rubber wear in some areas, which is something usual in mounts that have been in operation during long time. This phenomenon is not usually something of concern.
- The mounts have undergone some permanent set, which is also unavoidable in elastomers that are subjected to load. The measured permanent sets are not critical for the intended use of these marine engine mounts.
- In general, the damages observed in the marine engine mounts after the fatigue tests are not critical from the point of view of Ellebogen.

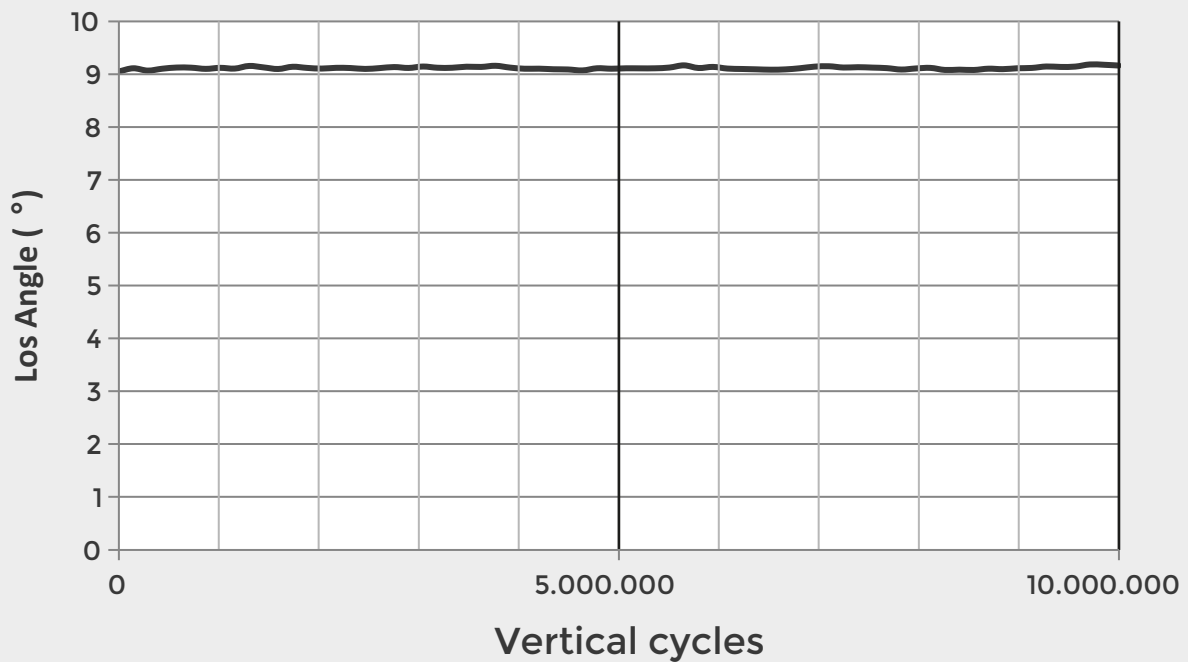
## Ellebogen 75 loss angle evolution:

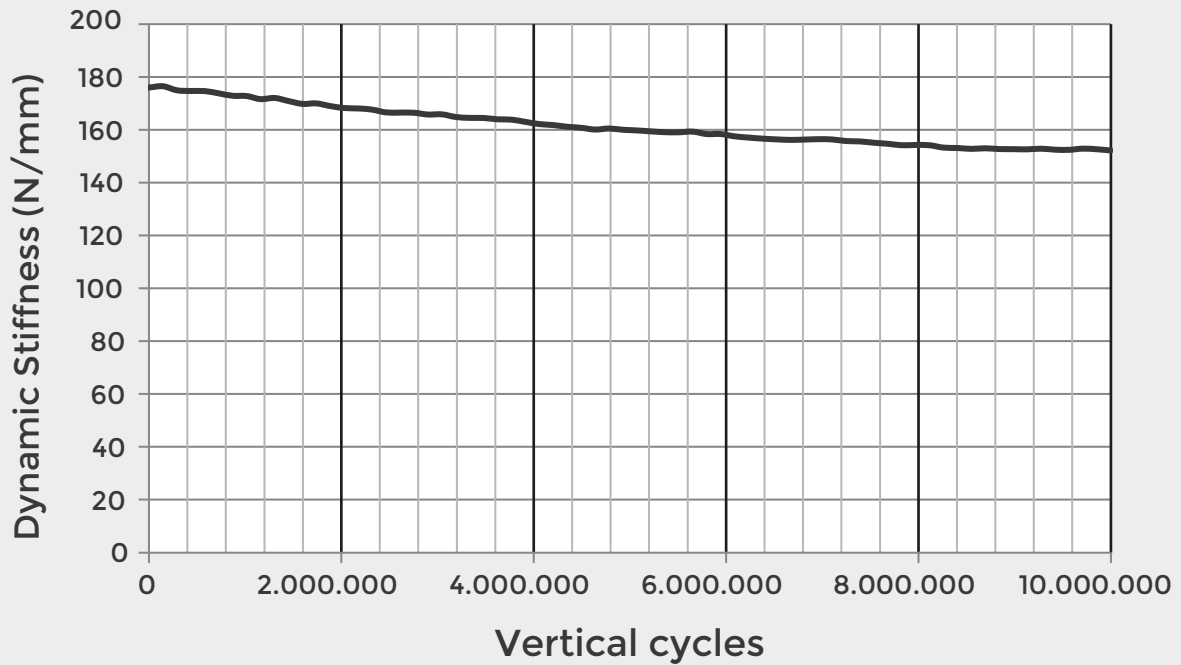
## Ellebogen 100 dynamic stiffness evolution:

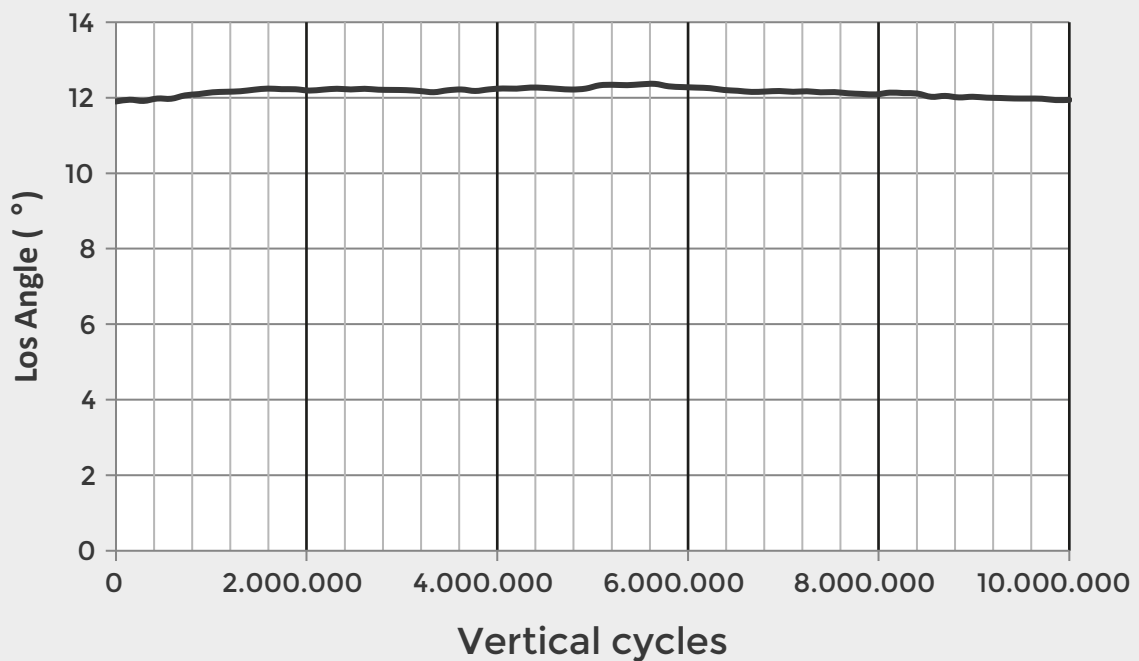
## Ellebogen 100 loss angle evolution:

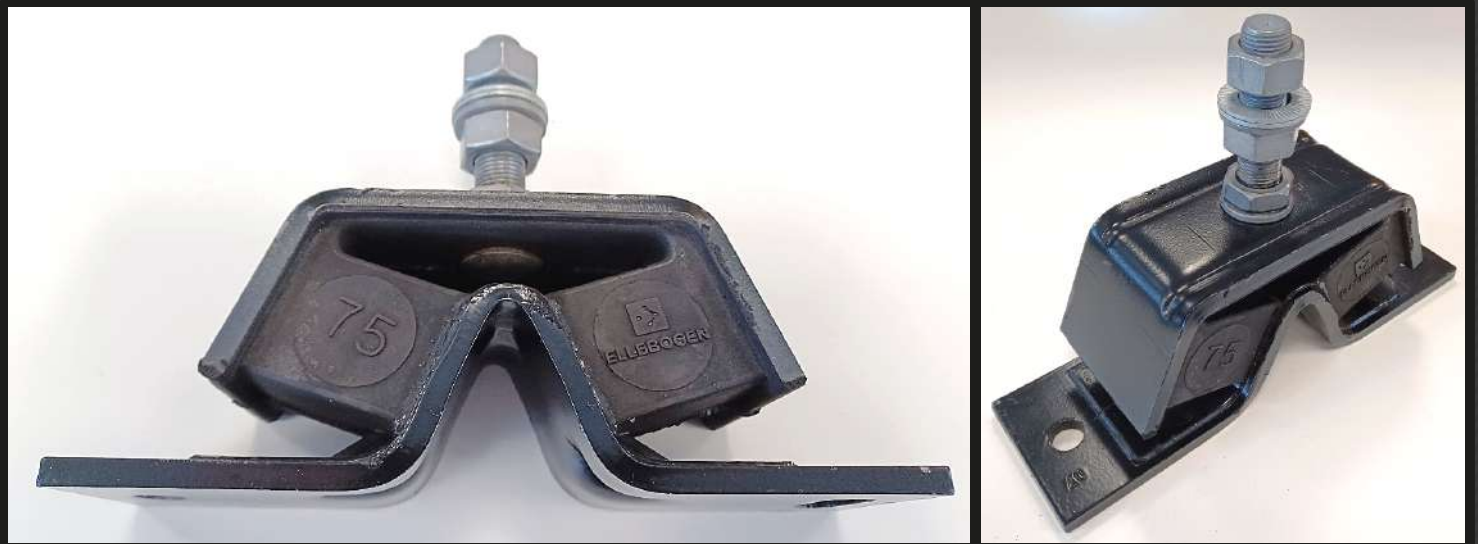
Pictures of the **Ellebogen 75** mount after the fatigue test:

Checking points		Evaluation of the top mount
Metal parts	Plastic deformation	No signs of plastic deformation.
	Corrosion	No signs of corrosion.
Rubber	Cracks	No signs of cracks.
	Bonding failure	No signs of bonding failure.
	Rubber wear	Some rubber wear can be seen in the mount.
	Permanent set	The mount shows a permanent set of 4mm (5%).
	Other damage	No signs of other damages.

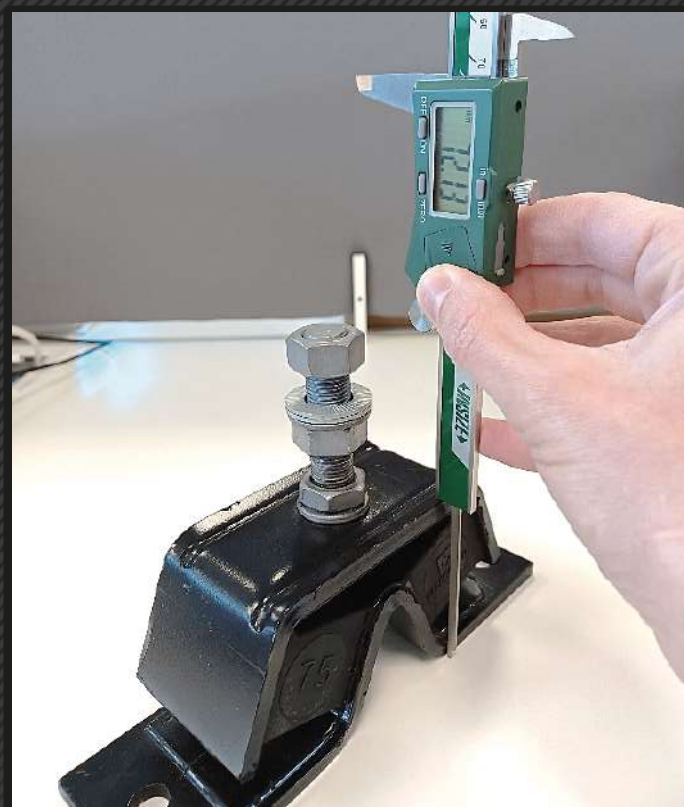
The Ellebogen 75 mount shows a height of about 72mm, which corresponds to a permanent set of about 4mm:

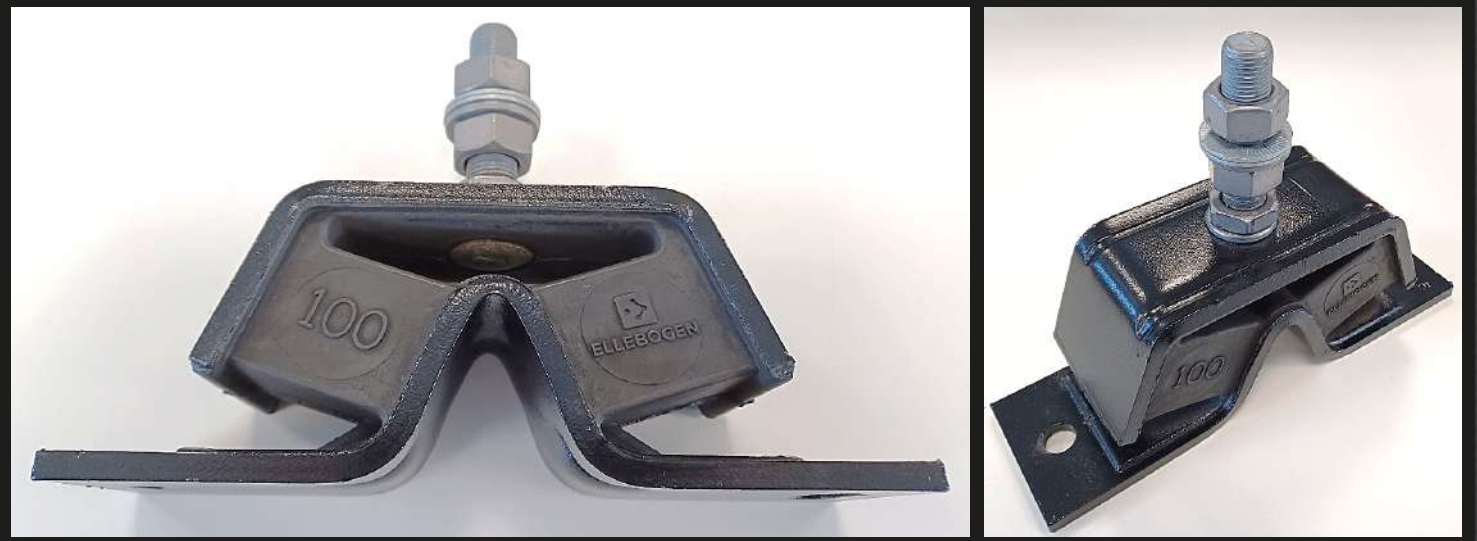
Pictures of the **Ellebogen 100** mount after the fatigue test:

Checking points		Evaluation of the top mount
Metal parts	Plastic deformation	No signs of plastic deformation.
	Corrosion	No signs of corrosion.
Rubber	Cracks	No signs of cracks.
	Bonding failure	No signs of bonding failure.
	Rubber wear	Some rubber wear can be seen in the mount.
	Permanent set	The mount shows a permanent set of 3mm (4%).
	Other damage	No signs of other damages.
